POST-TEST ANALYSIS OF BRUNSWICK
MOD SHELTER TESTED IN DICE THROW

BY JOHN M. CALLIGEROS

JULY 1979

THE MITRE CORPORATION

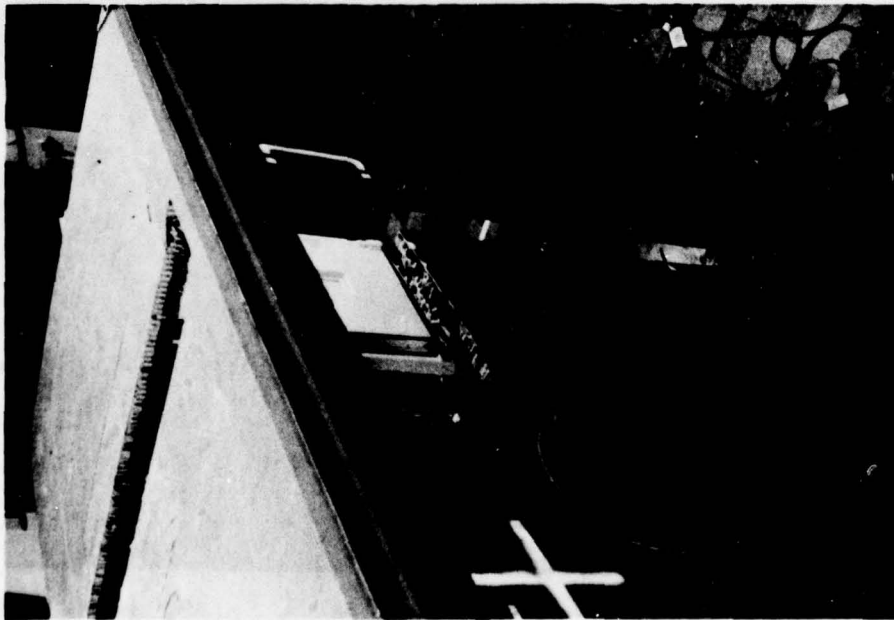
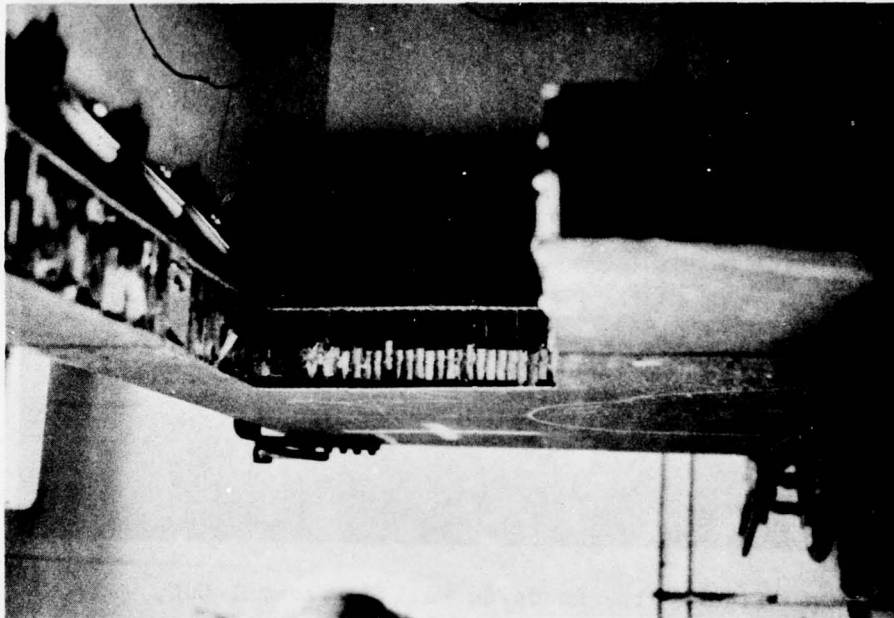
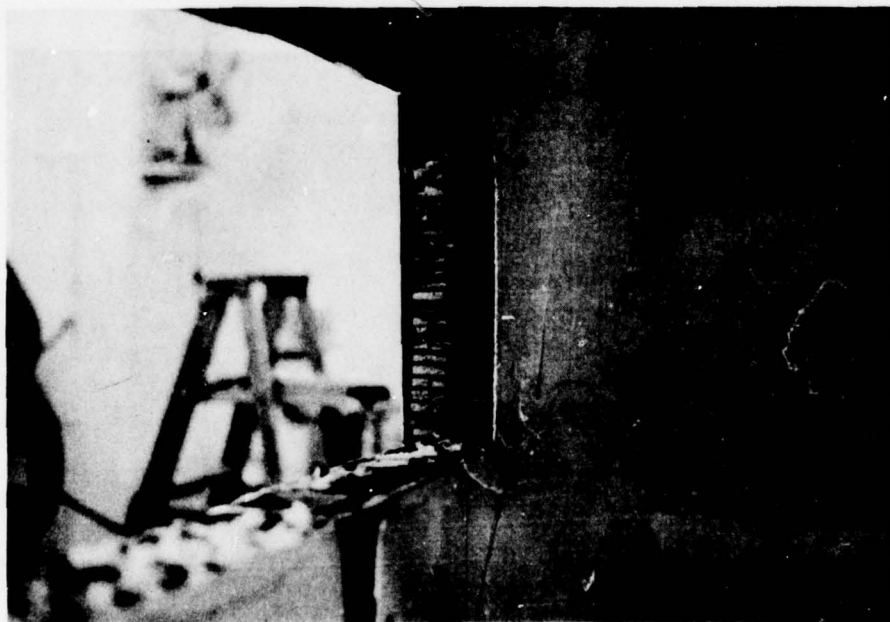
The 27-inch horizontal cut in the roadside wall is shown in Figures 29, 30, 31, 32 and 33. The concave-like deflection of the

Figure 29. View Toward Door End Wall

Figure 30. Horizontal Cut in Roadside Wall, View Toward Front End Wall

Figure 31. Roadside Wall Horizontal Cut,
Showing Vertical Extrusion

Figure 32. Interior View of Roadside Wall Cut

Figure 33. Exterior View of Horizontal Roadside Wall Cut, Showing Core Damage and Vertical Extrusion.

roadside wall is apparent in Figure 29. Delamination is seen in Figure 30, indicating the extent of this type of failure towards the center of the wall. This cut also confirmed the presence of the vertical extrusions (Figures 33 and 34). These extrusions were connected to the outside and inside facing sheets by rivets through the joint splices. In addition, one side of the extrusion was bonded to the outside facing sheets and the opposite side was bonded to a thermal barrier which, in turn, was bonded to the inside facing sheets. Foaming adhesive was inserted on the other two sides in contact with the honeycomb material. Figure 35 illustrates the cross-section of the extrusion installation.

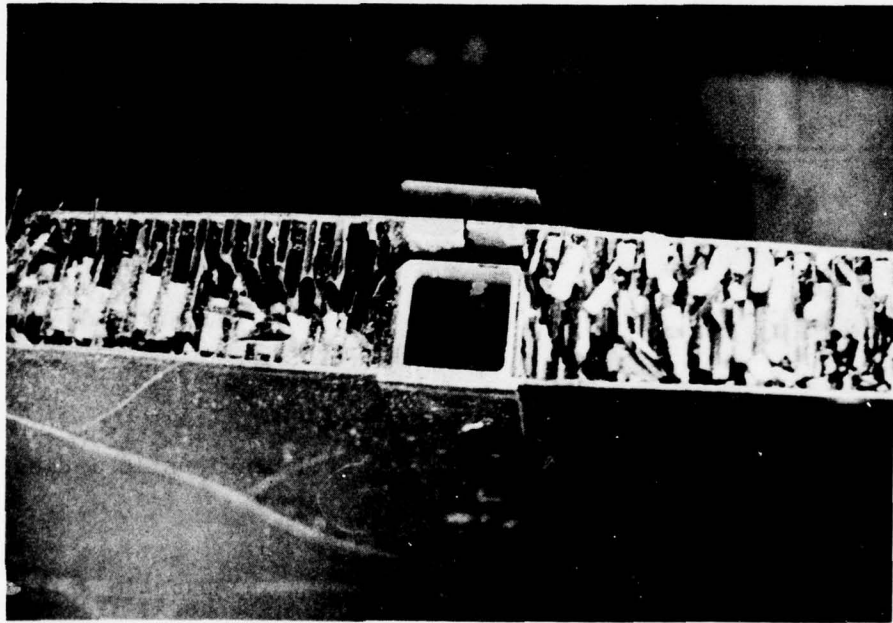
Considerable internal damage resulted at the vertical extrusion (Figures 33 and 34). There was complete failure of the thermal barrier and the foaming adhesive, and extensive shear failure of the honeycomb core. The extrusion was also bent along its axis.

Figure 34. Vertical Extrusion in Roadside Wall, From Outside.
Core Failure, Foaming Epoxy and Thermal Barrier.

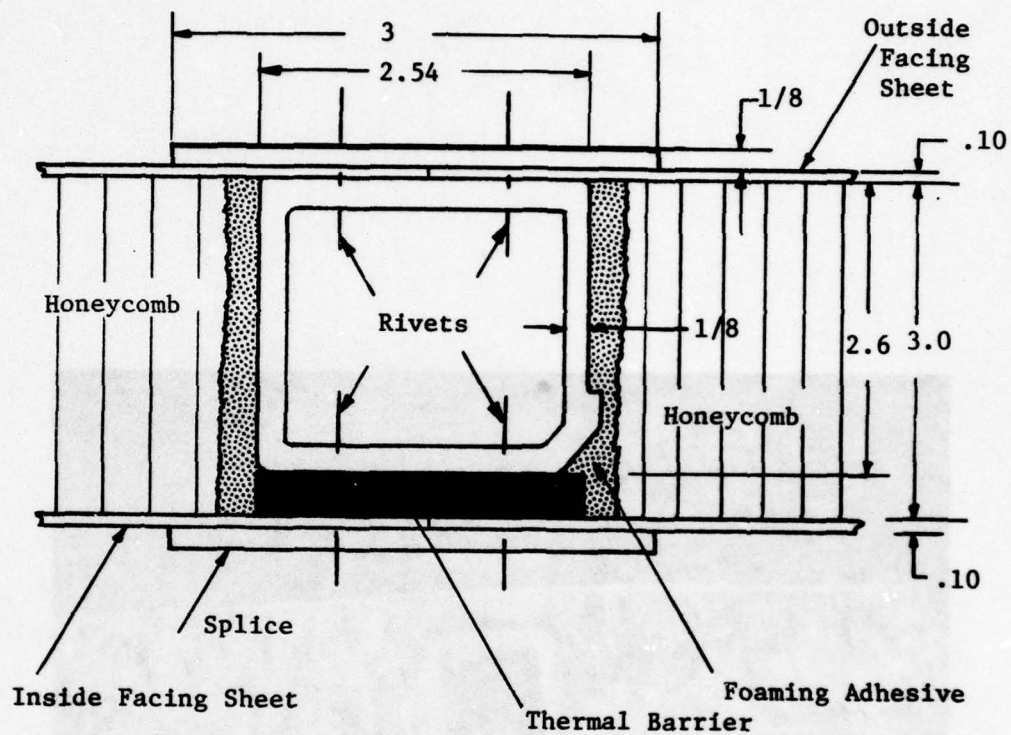
Figure 35. Vertical Extrusion Assembly in Roadside Wall

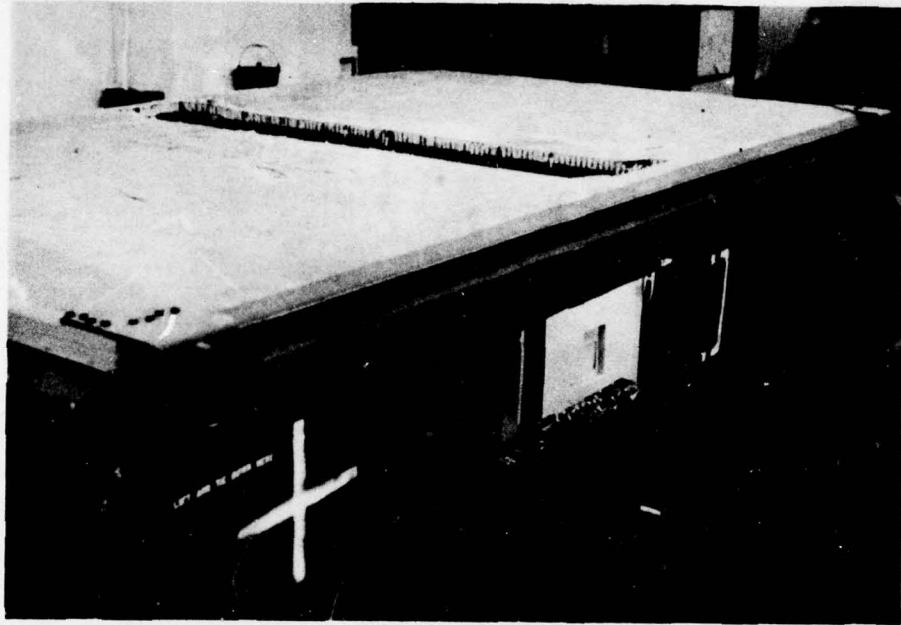
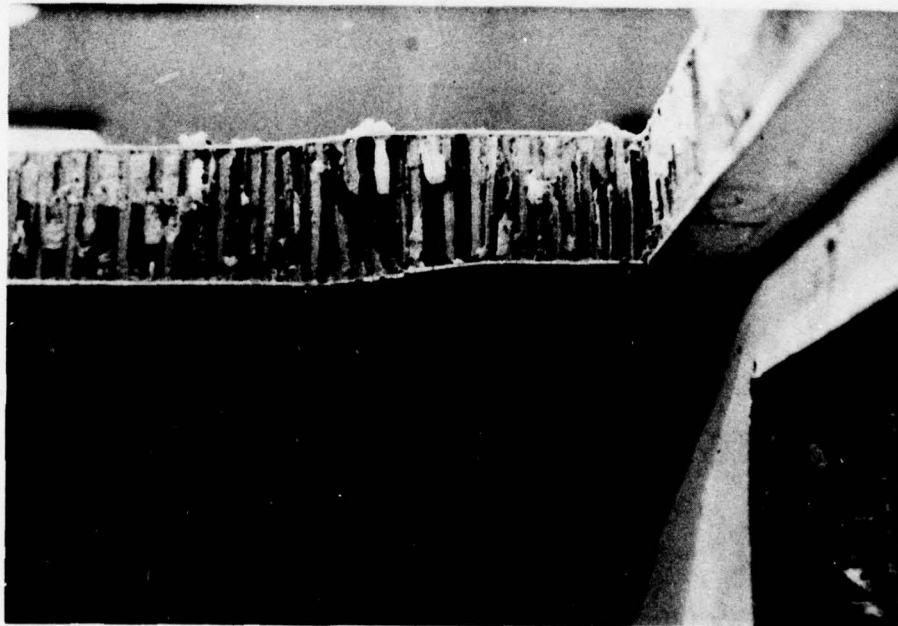
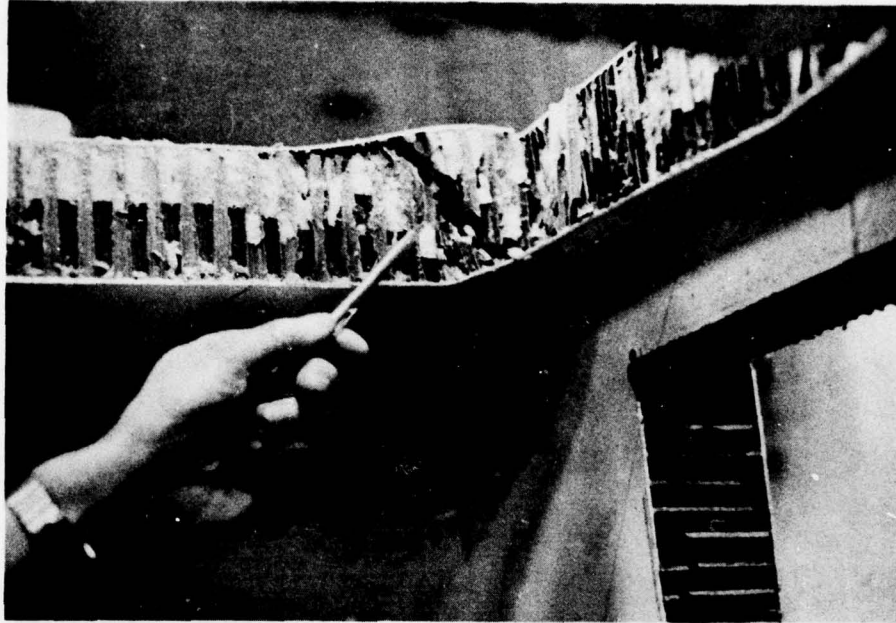
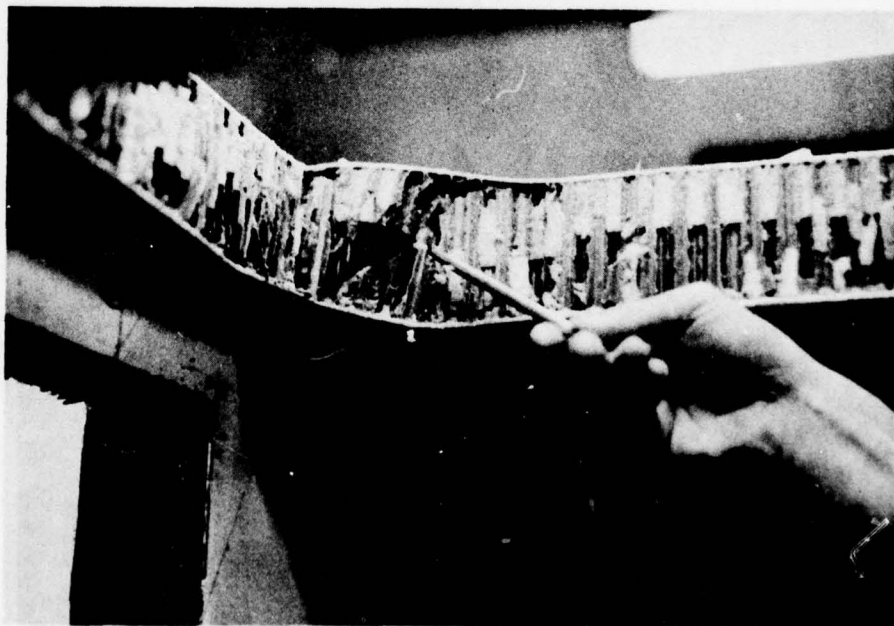
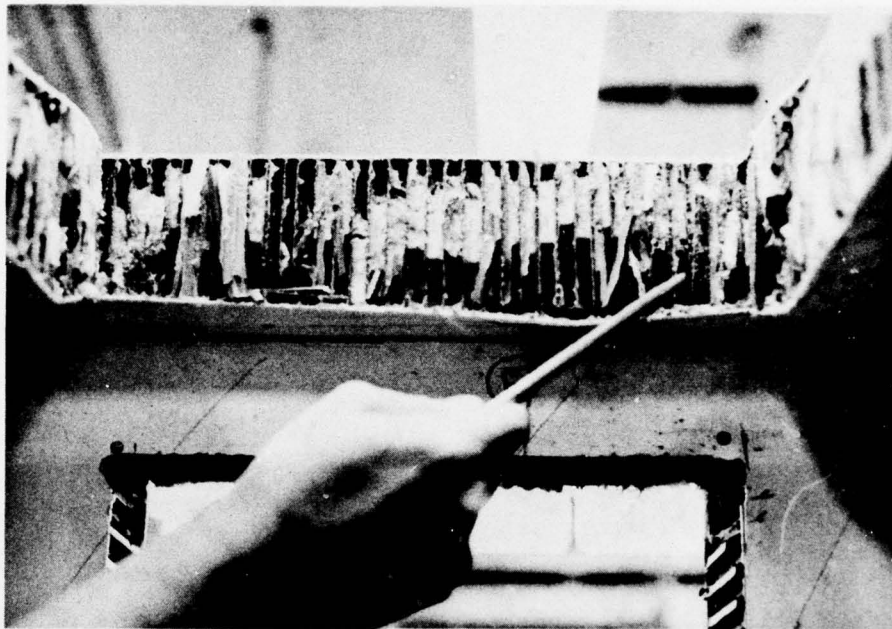
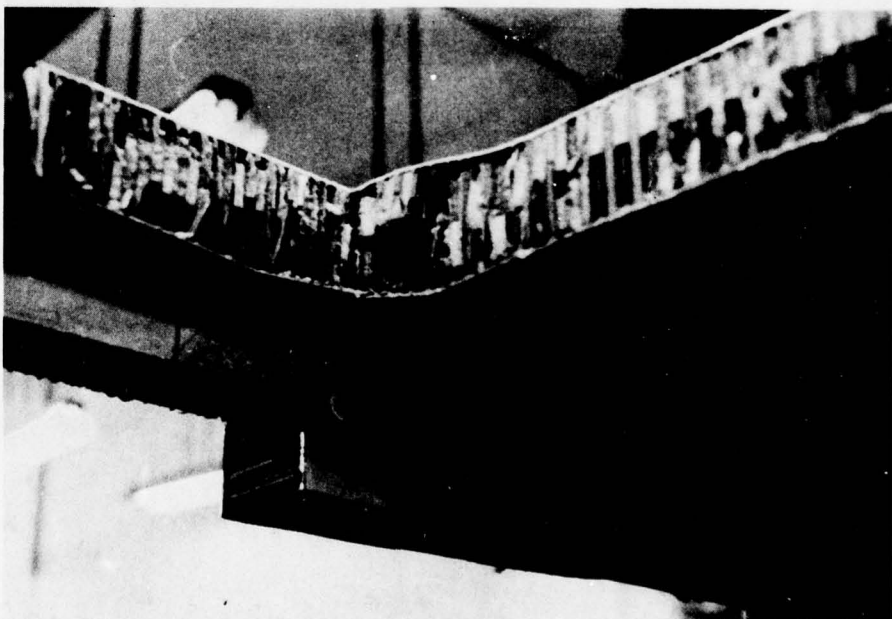
Figures 36, 37, 38, 39, 40 and 41 show the roof cut and corresponding core failures. A good indication of the roof deformation mentioned earlier, showing the edge depressions and the flat central region, is given in Figure 36. The internal failure in the roof cut (Figures 37, 38, 39, 40, 41 and 42) was clearly shear failure of the core near the panel edges due to the downward over-pressure loading. The classical 45 degree shear failure planes are evident in the photographs. The shear failure was present on all faces of the roofside cut, away from the central flat portion where no failure of any type occurred. No delaminations were present as in the roadside cut. The foaming adhesive had failed at the curb-side end of the roof cut. Figures 37, 38 and 41 show the shear deformation beginning along the edges of the upper shock-isolation mounts. A view of the section removed from the roof is shown in Figure 42.

Figure 36. View of Roof and Roadside Wall Cuts

Figure 37. Roof Cut Near Curbside Wall, View Toward Front End Wall. Partial View of Curbside Cut

Figure 38. Roof Cut Near Roadside Wall,
View Toward Door End Wall

Figure 39. Roof Cut Near Roadside Wall,
View Toward Front End Wall

Figure 40. Roof Cut Near Roadside Wall, View Toward Roadside Wall

Figure 41. Roof Cut Near Roadside Wall, Showing Shear Deformation Along Edge

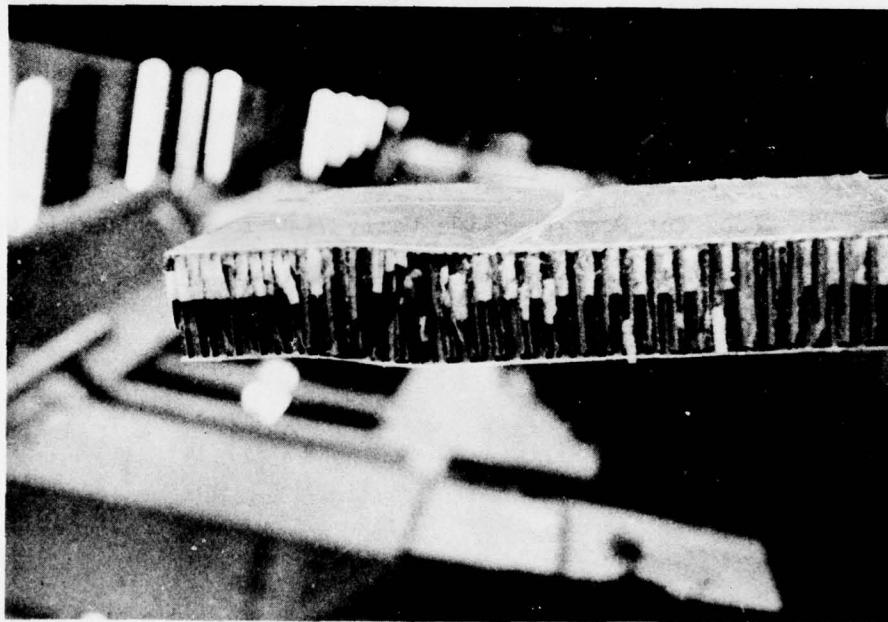
Figure 42. Section Removed from Roof

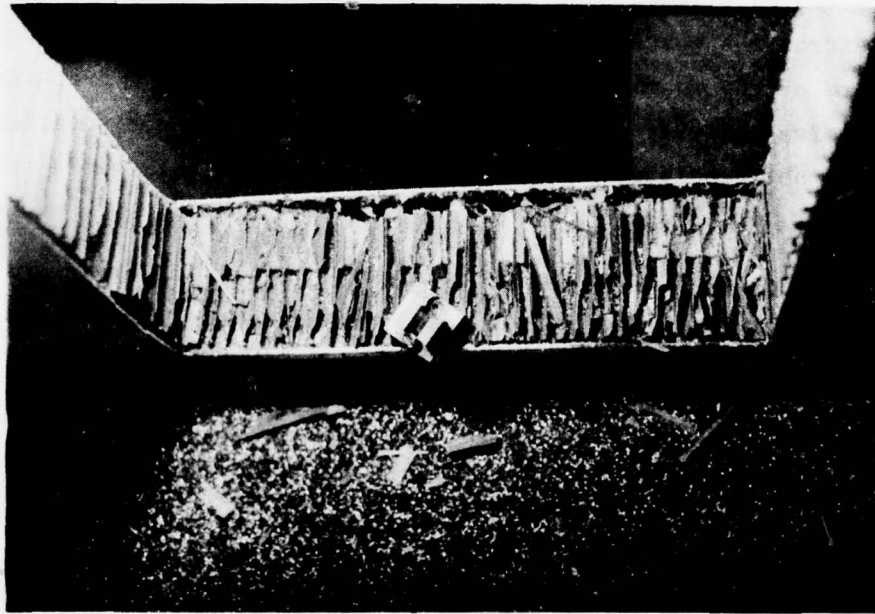
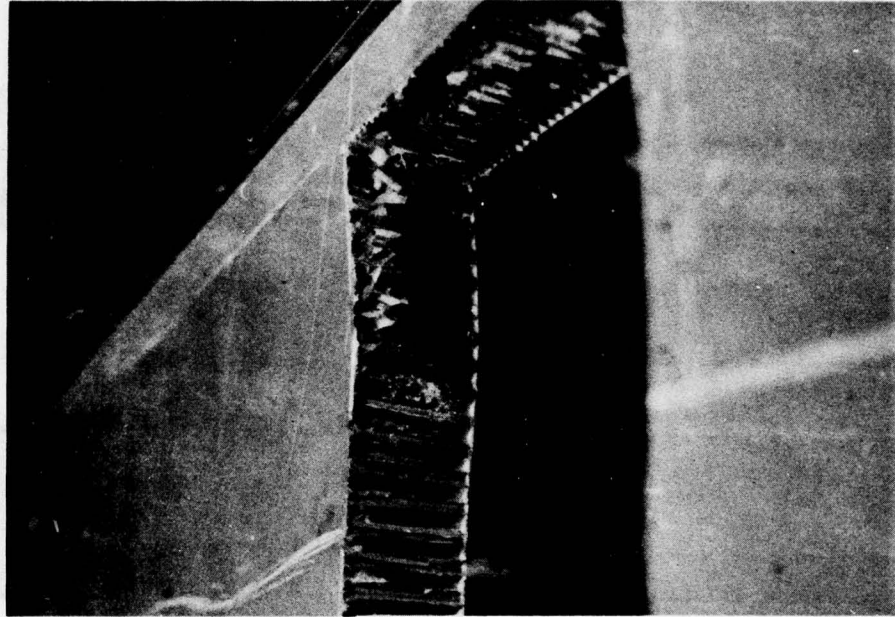
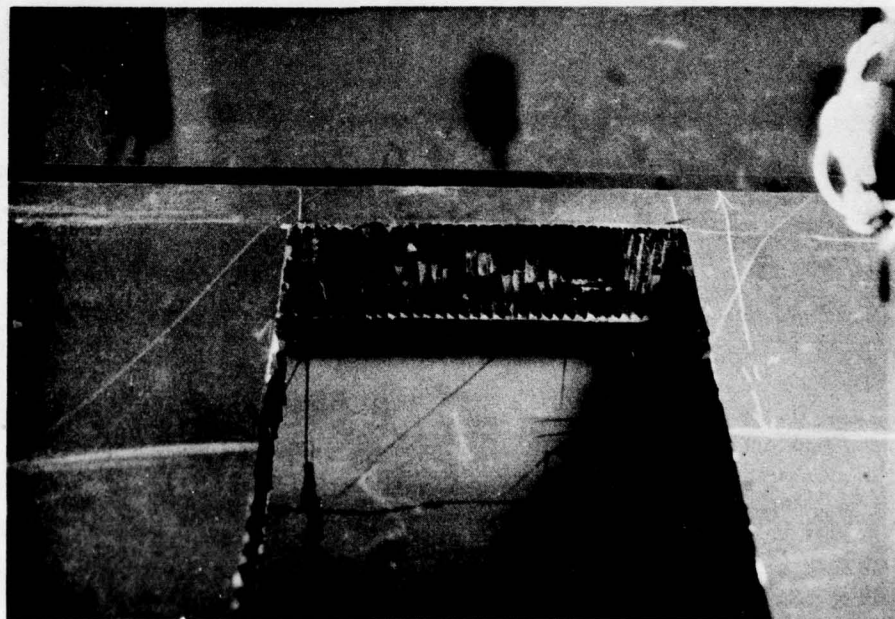
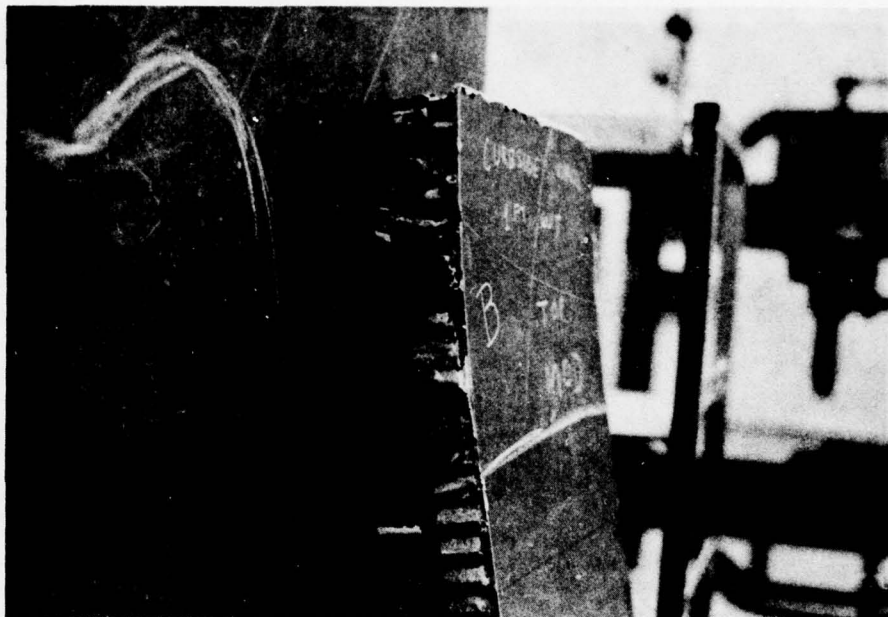
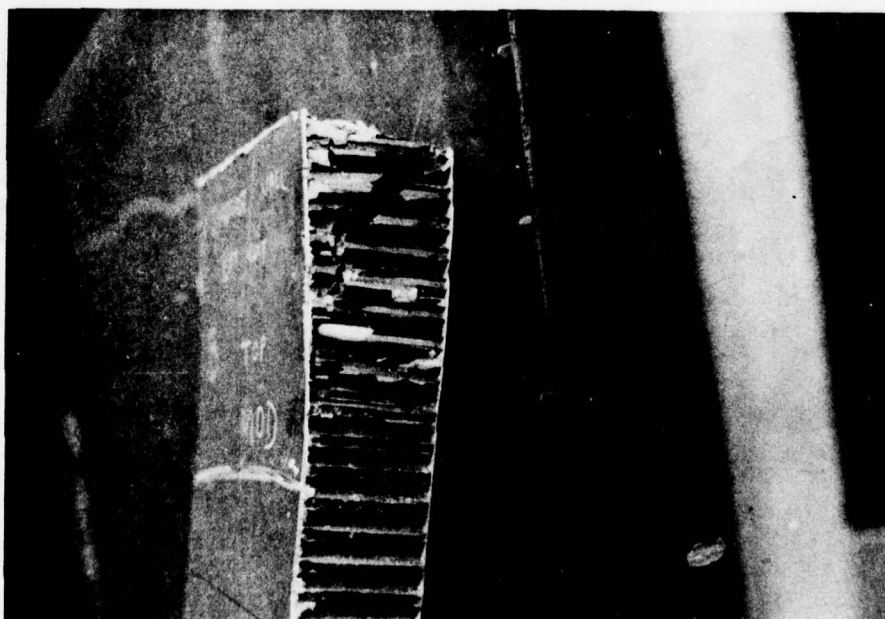
Failures in the curbside wall-cut are shown in Figures 43, 44, 45, 46 and 47. The upper surfaces of the cut showed shear failure of the core. Extensive core damage resulted at the upper part of the cut (Figure 45) as well as failure of the thermal barrier and the foaming adhesive. At the base of the cut and the sides, Figure 43, delamination occurred, again with some evidence of adhesive failure and core failure at the adhesive surface.

Figure 43. Interior View of Base of Curbside Wall Cut

Figure 44. Curbside Wall Cut, Exterior View Toward Door End Wall

Figure 45. Upper Portion of Curbside Wall Cut

Figure 46. Upper Left Edge of Curbside Wall Cut

Figure 47. Upper Right Edge of Curbside Wall Cut

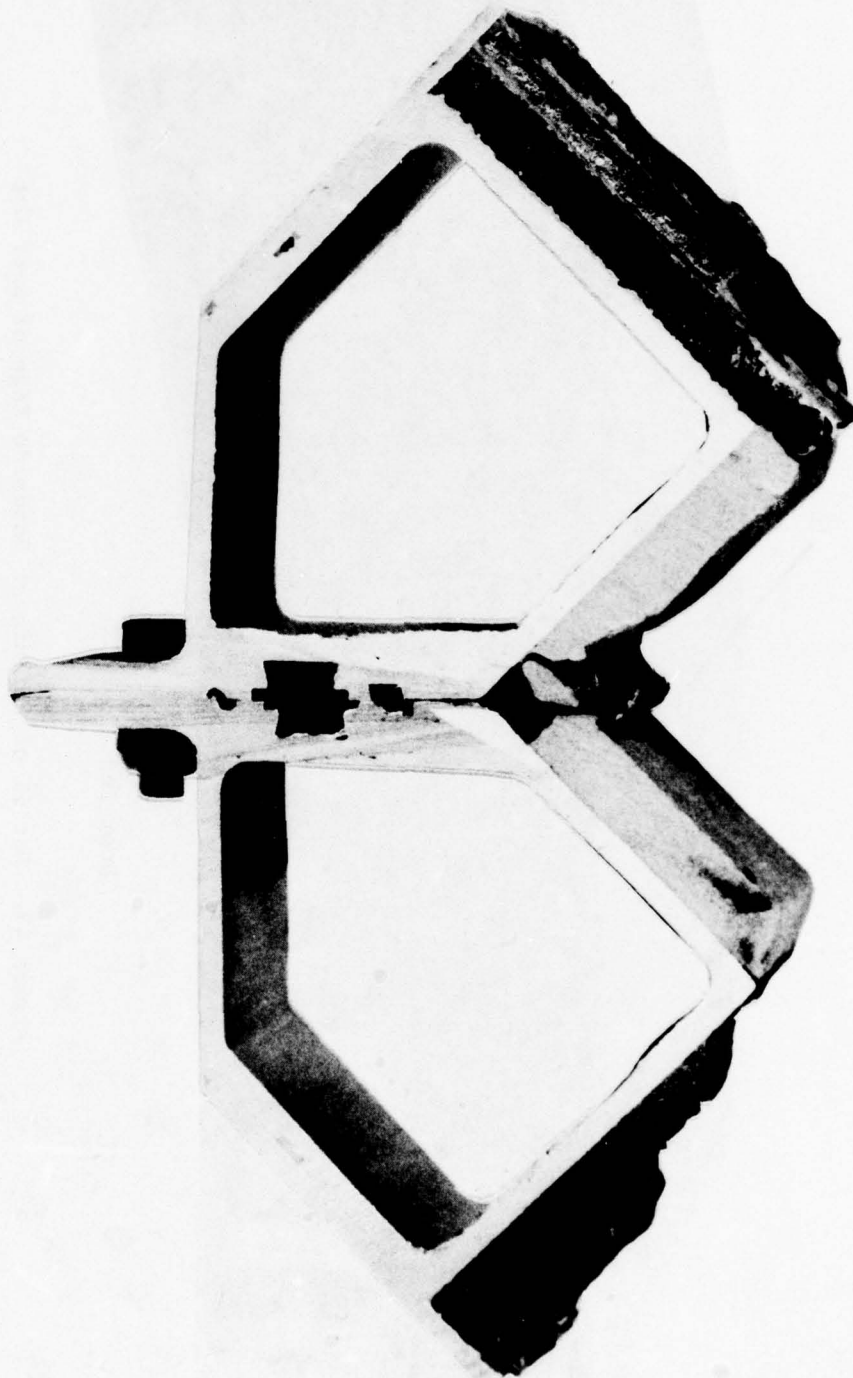
A portion of the edge extrusion above the roadside wall cut was also removed (Figure 48). The edge extrusion actually consists of two extrusions bolted together for modular construction. Shear failure of the foaming adhesive (dark region) and some cracking of the thermal barrier (light region) are apparent. Some shearing also is noticeable along the plane where the two extrusions are bolted.

Figure 48. Section of Upper Edge Extrusion Removed From Roadside Wall

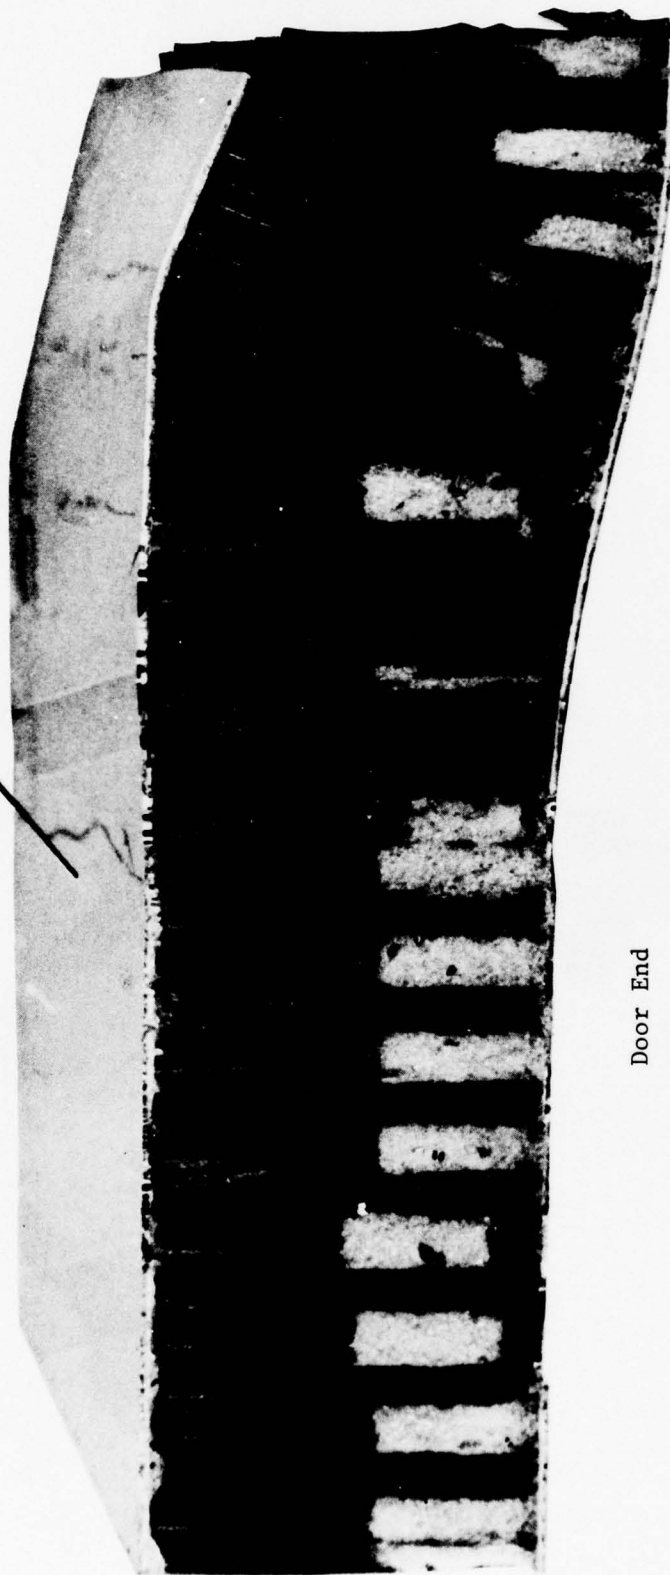
More detailed photographs of the core shear failure are shown in Figure 49 (roadside edge of the roof cut) and Figure 50 (upper right-hand portion of the curbside road cut).

Figure 49. Detail of Failure at Roadside Edge of Roof Cut

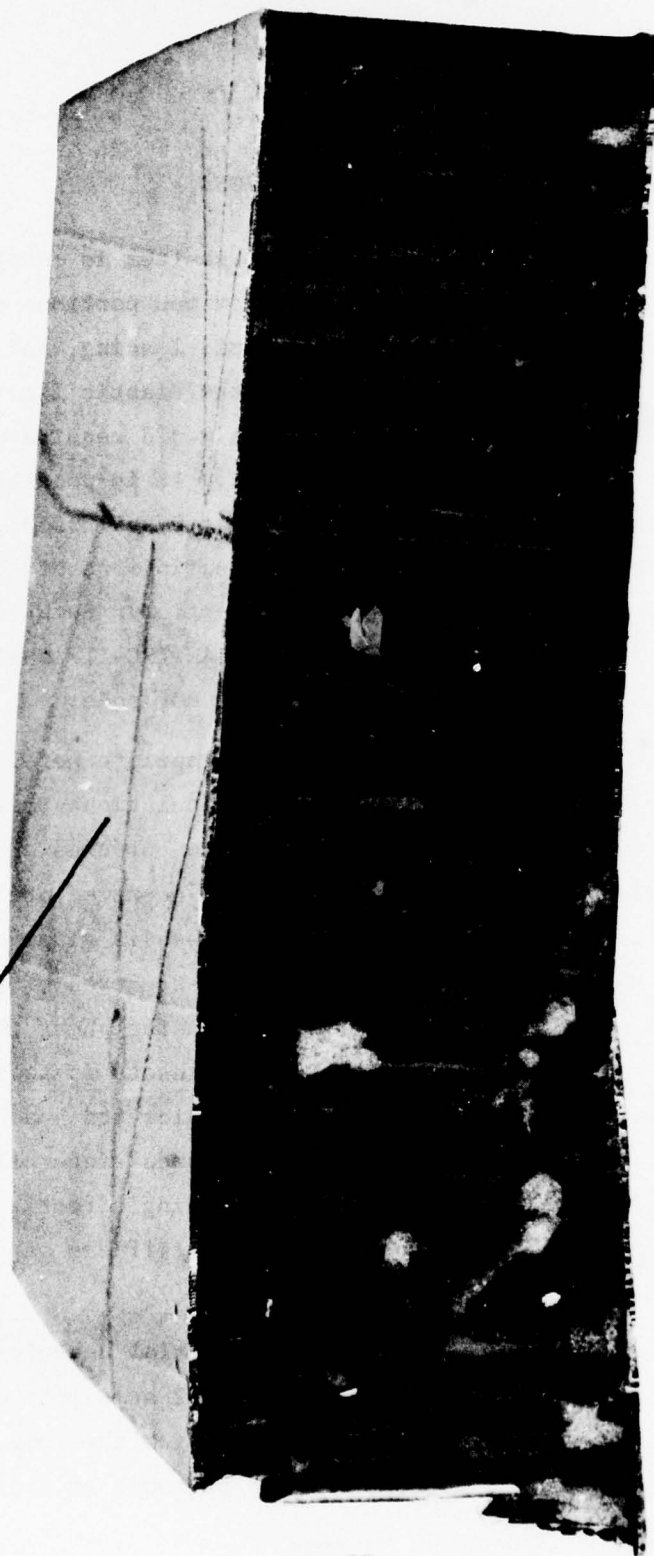
Figure 50. Detail of Failure at Upper Right Hand Portion of Curbside Road Cut

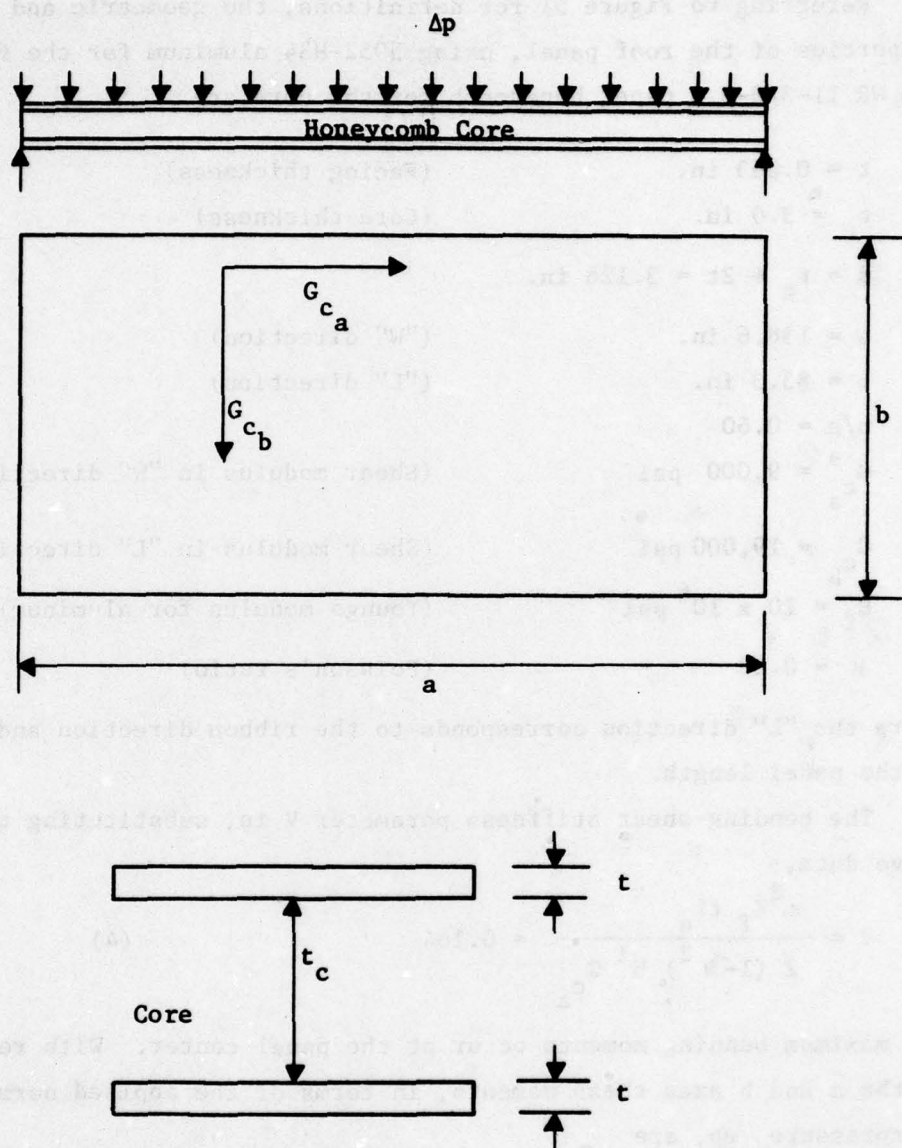
The maximum bending moments occur at the panel center. With respect to the a and b axes these moments, in terms of the applied normal overpressure Δp , are

Figure 51. Geometry of Honeycomb Sandwich Panel Under Normal Loading
